**ST MARKS PRIMARY SCHOOL,
LOWER BOSTON ROAD,
HANWELL**

**Structural Report for Demolition of
Existing Caretakers House**

Report Ref: 1634

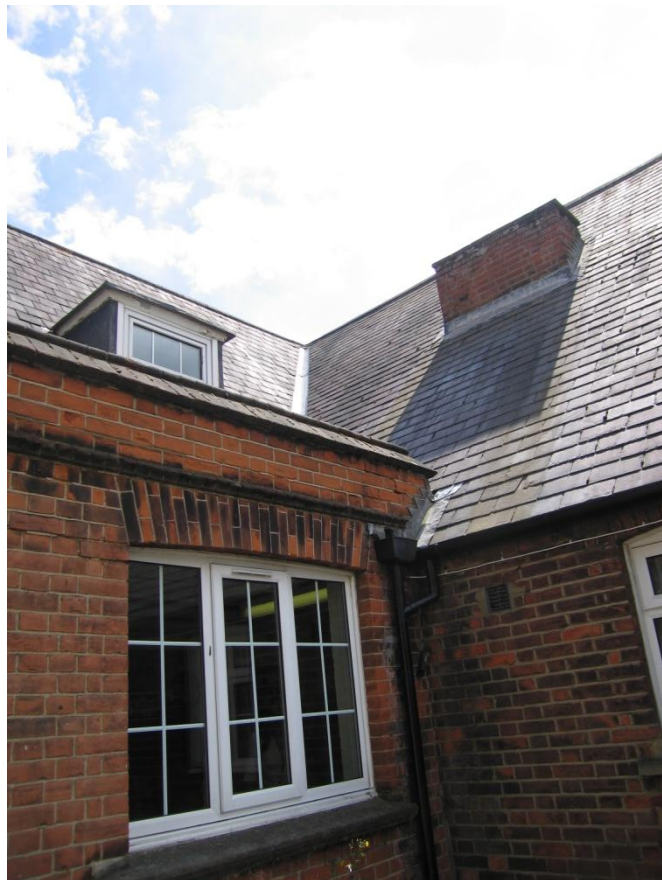
The roof to the caretakers house extends over the adjacent main access corridor and ties into the side of the pitched roof of the main school building (Photo 1). It appears that the timber trusses span side to side across the house and bear onto structural walls either side (Photo 2). To the right hand side (RHS) the roof stops at 1st floor eaves, however, on the left hand side (LHS) the roof continues down to ground floor eaves level – it is assumed that this is achieved with loose timber rafters.

Photo 1 – roof of caretakers house passing over the corridor

The roof to the existing school buildings appears to have been altered to allow for the connection of the caretakers house roof and this will probably require some structural works to maintain its integrity once the demolition is complete.

Once the caretakers house has been demolished a new tiled roof covering will have to be applied to the hole remaining in the roof of the existing school building. The final applied loads on the roof will, however, be reduced as the load added to the roof from the tiles will be less than the load that was being applied by the roof of the caretakers house

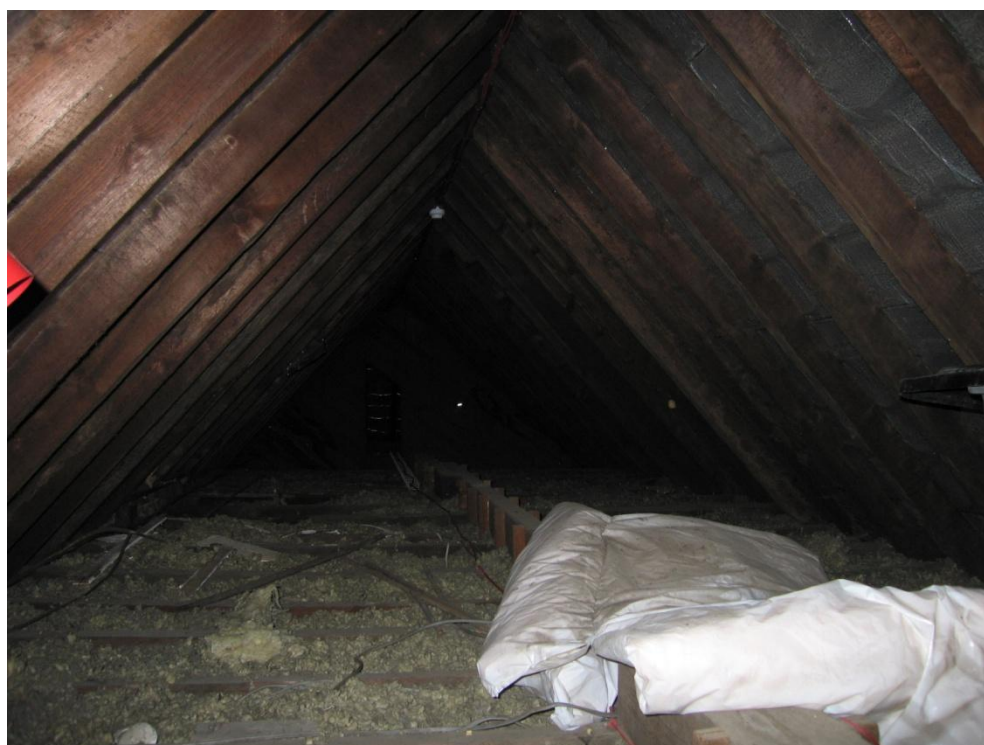
Photo 2 – inside roof space to caretakers house

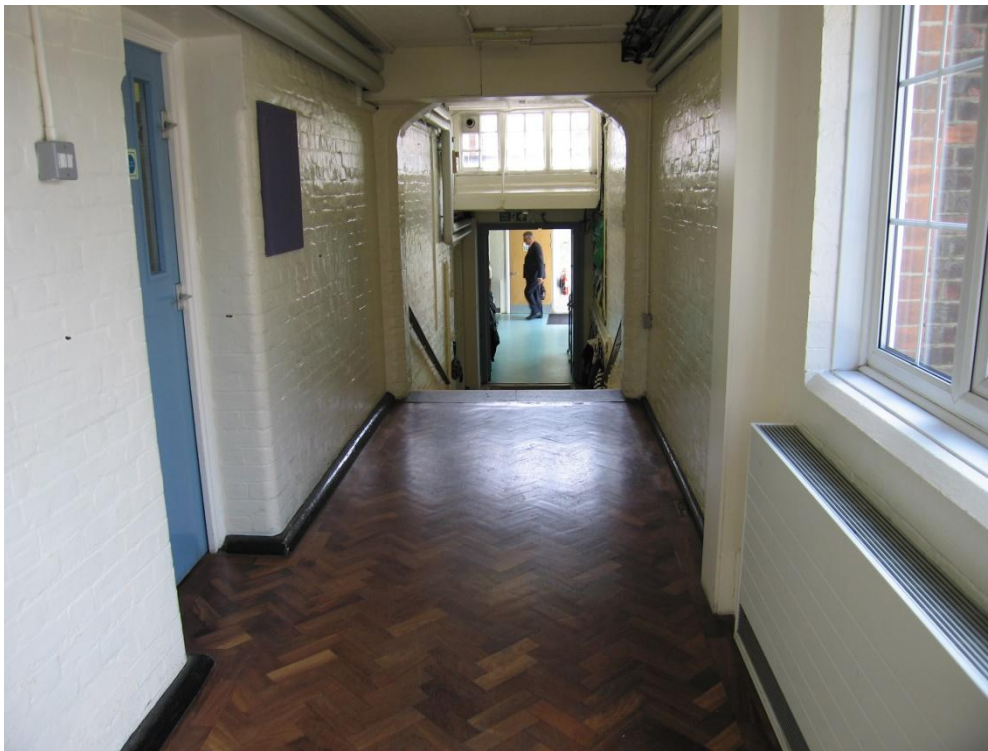
The main loadbearing sidewalls of the house also extend across the school corridor and are supported on beams spanning across the corridor to the inner classroom wall (Photo 3). On the RHS the house appears to wrap around the corner of the main two storey school building (Photo 4), following the line of the wall across the corridor below.

Photo 3 – school corridor with caretakers house to RHS

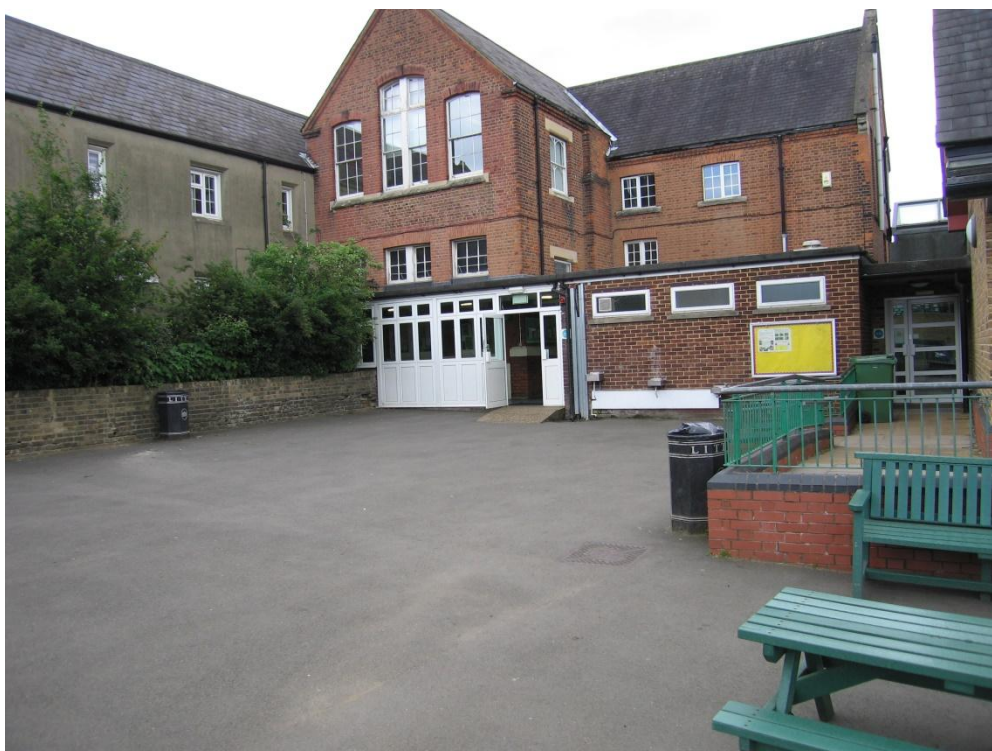
Photo 4 – rendered caretakers house wrapping around school building

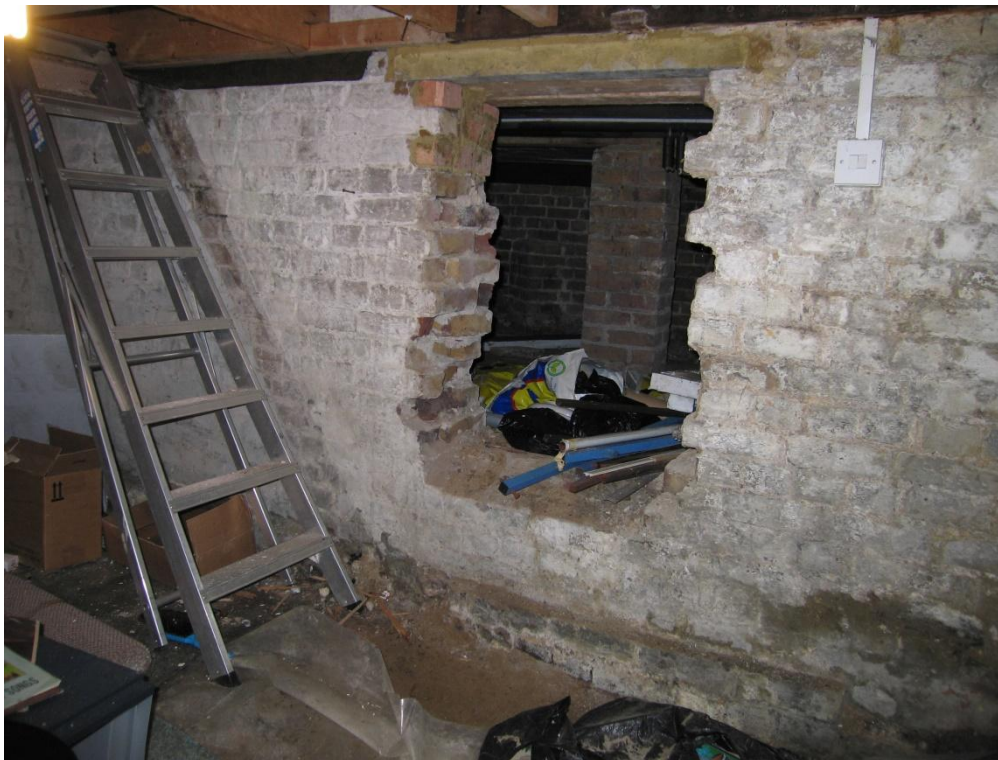
The basement is approximately 1.7m high to the front of the house reducing to approximately 1.4m adjacent to the existing school corridor (Photo 5). The walls appear to be constructed in solid masonry and there is no evidence of water ingress or significant damp. There are a number of masonry piers constructed to support the ground floor above.

Photo 5 – basement to caretakers house

The existing basement in the caretakers house is proposed to be filled with compacted hardcore material, however, the section of the basement immediately adjacent to the school may be left open to avoid any lateral loads being transferred to the foundations of the school buildings.
